## Product Operation Notice

**Notice ref:** CL-PON-EMP-300320  
**Date:** 2<sup>nd</sup> of April 2020  
**Product:** Coolon Emergency Pack

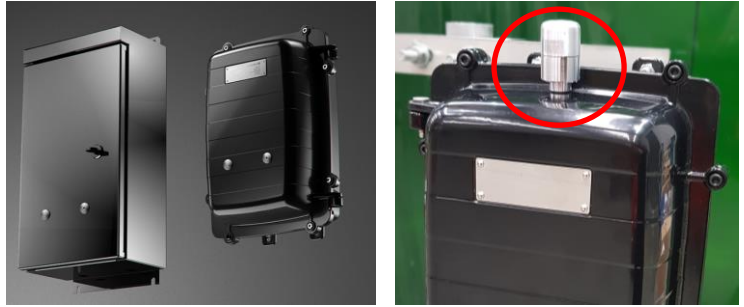
Some of our external Emergency Packs (EMP) have recently been reported to experience enclosure deformation and/or rupture. While the number of reported cases is very low (< 0.07% of units), we urge all users of the EMP to take the recommended action to eliminate any potential risk.

This notice supersedes our previous notice **CL-PON-EMP-230419** which was issued in April 2019 relating to the use of Lead Crystal batteries within the emergency packs. This notice is applicable to all EMP units which do not have a High Capacity Breather Valve installed – circled in top right image.

We recommend that all external EMP units be fitted with our High Capacity Breather Valve. This valve has been designed and verified to provide safe operation by preventing opportunity for volatile hydrogen concentration build up.

Please contact and advise us of the number of active external EMP units on your site so that we may provide you with the necessary valves and safe work instructions.
